IN-DEPTH INSPECTION REPORT

ELEMENT SPECIFIC BRIDGE WORK

B.I.N. 1076620

FEATURE CARRIED Grand Central Parkway - Westbound C-D

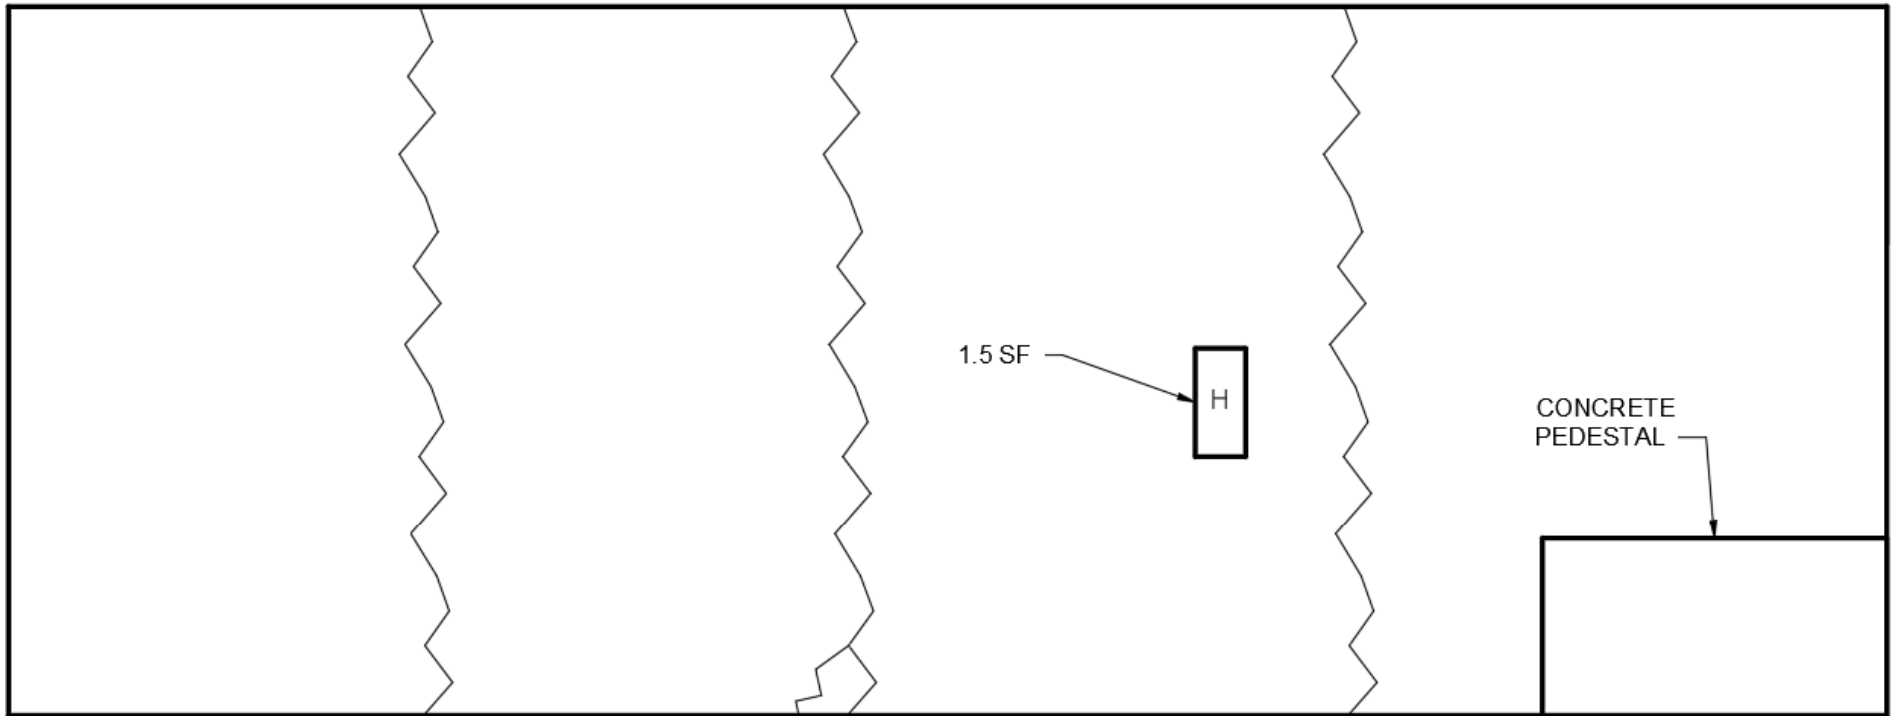
BEGIN ABUTMENT

Both abutments are still in fair condition and fully functional. The Begin (West) Abutment exhibits a 1.5 SF hollow area approximately 4 feet above the roadway, multiple full height cracks up to 1/16". The End (East) abutment exhibits multiple hollow areas up to 18 SF, multiple cracks up to full height of the abutment and 1/16" width with heavy efflorescence. (See Photos 4-6)
